**NATIONAL TRANSPORTATION SAFETY BOARD**  
**Office of Marine Safety**  
**Washington, D.C. 20594**

**Survival Factors Group Chairman's**  
**Factual Report**

**U.S. Navy/ USS *Greeneville* (SSN772)**

Ehime Prefecture/ *Ehime Maru*

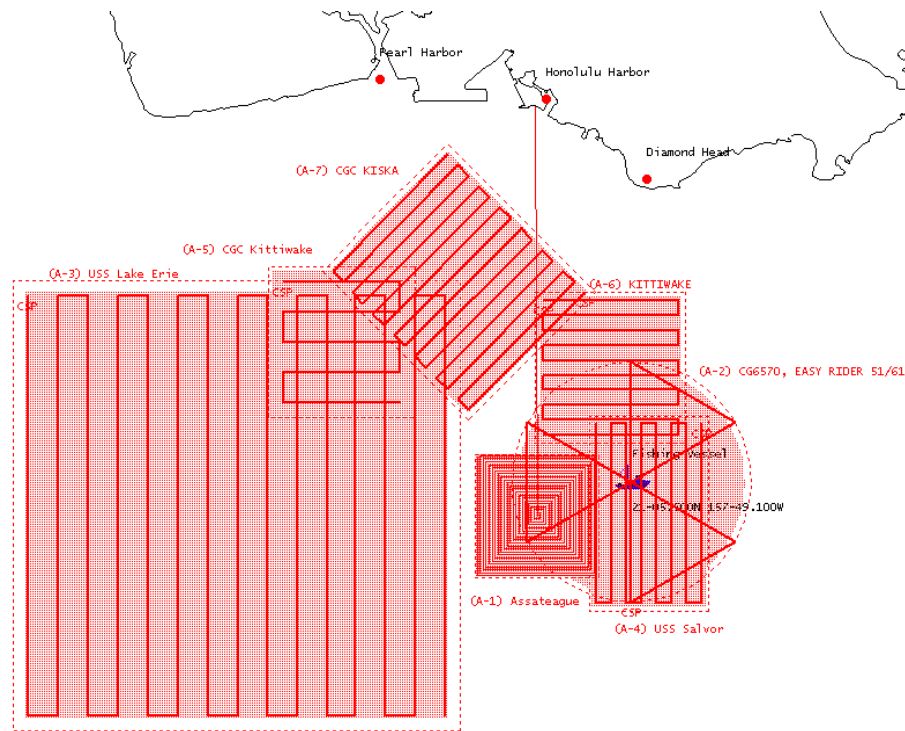
The USS Lake Erie, a cruiser, assumed OSC duties for both surface and air assets at 2057W. It maintained control of the following assest through the night of February 9<sup>th</sup>: USS Greeneville, USS Salvor, USCGC Kiska, USCGC Kittiwake, 2 USN P-3 airplanes, 2 USN SH-60 helicopters, one USCG HH-65A helicopter. The search areas covered designated "ALPHA", are outlined in attachment three and illustrated in figure 1 below.
